# SERVICE BULLETIN

TR-9000

#824

SUBJECT: TR-9000 CW, SSB TX INSTABILITY

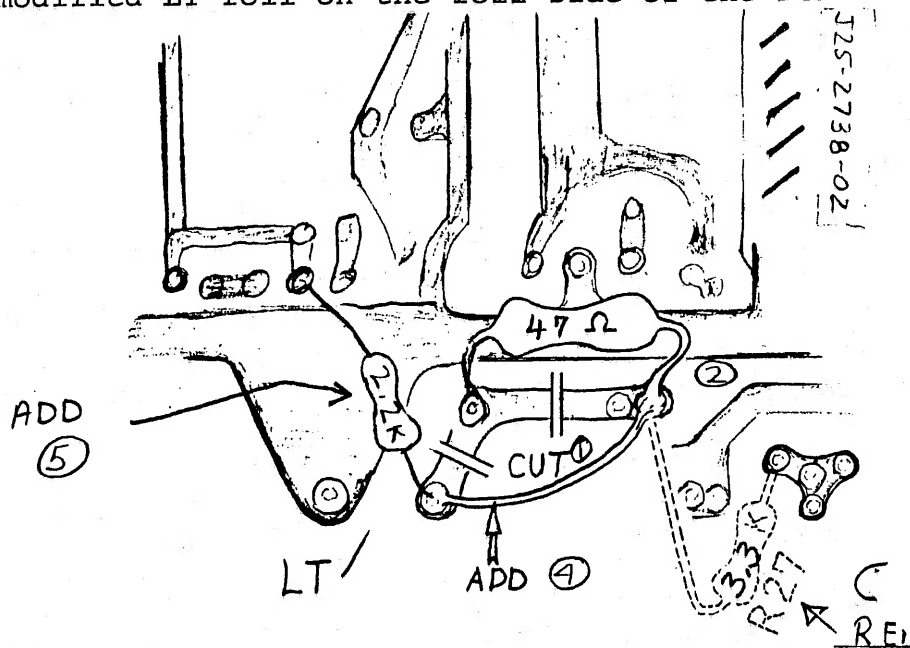
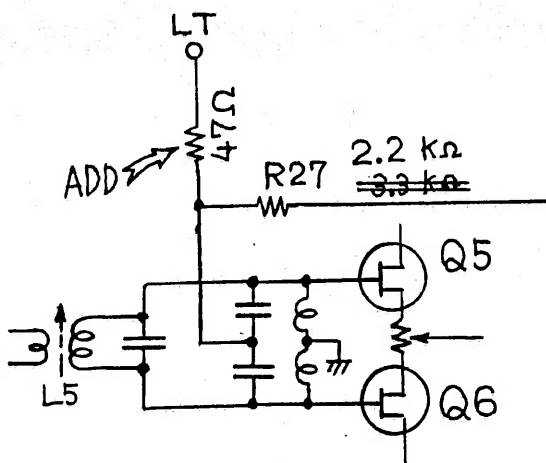
Complaints of FMing in SSB, or CW chirp may be eliminated by minor changes to the TX mixer circuit.

On the TX unit X56-1370-10, perform the following changes:

1. Cut the LT foil path.
2. Install a  $47\Omega$  resistor on the foil side of the PCB.
3. Remove R27,  $3.3K\Omega$  and delete.
4. Jumper the cut foil.
5. Install a  $2.2K\Omega$  resistor from Q12 collector to the modified LT foil on the foil side of the PCB.
